AJNR Am J Neuroradiol 1997, 18 (3) 478-481 http://www.ajnr.org/content/18/3/478

Cerebrospinal Fluid Otorhinorrhea in Patients with Defects through the Lamina Cribrosa of the Internal Auditory Canal

Prashant G. Shetty, Manu M. Shroff, Milind V. Kirtane, and Swati S. Karmarkar

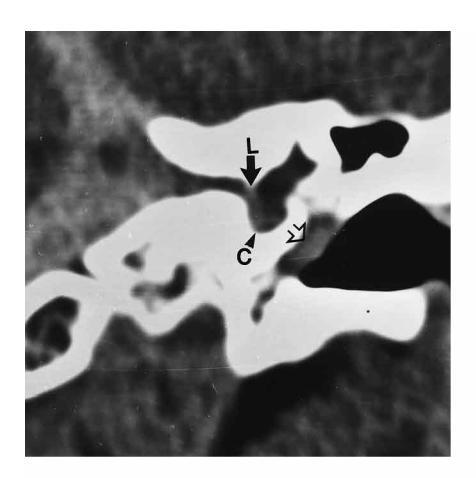
Fig 1. Postcisternography coronal high-resolution CT scan through the left internal auditory canal shows a defect in the left lamina cribrosa (L). The left vestibulo-cochlear complex is enlarged and contrast material is seen within the middle ear cavity (*open arrow*). Note the enlarged basilar turn of the cochlea (C).

A CT cisternographic study, which had been performed at an outside institution, showed a complete absence of the left lamina cribrosa. Contrast material was seen in the middle ear cavity, having leaked through a defect in the lamina cribrosa and from there to an enlarged vestibule through the oval window (Fig 1). The cochlea was represented by a saclike diverticulum from the vestibule without apical turns.

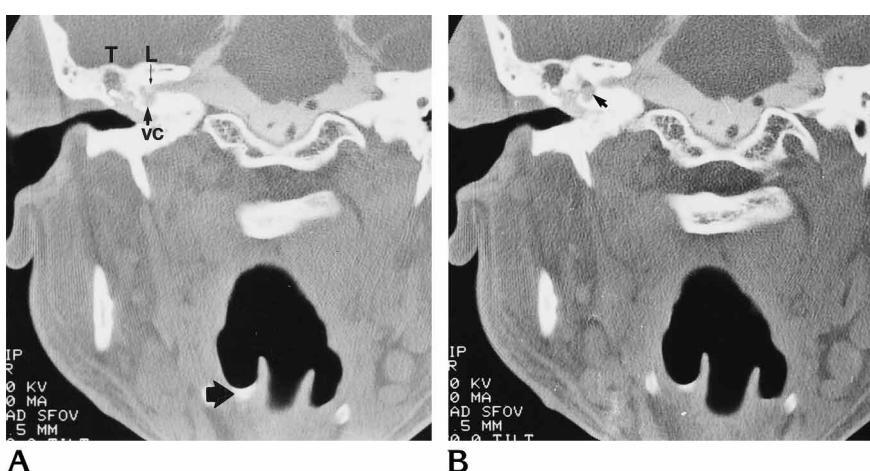
Fig 2. *A*, Postcisternography coronal high-resolution CT scan through the right internal auditory canal shows a defect of the lamina cribrosa (L) with contrast material leaking into the right middle ear cavity. The right tegmen tympani (T) is intact. Note contrast material on the right side of the hypopharynx (*large wide arrow*), presumably egressing from the eustachian tube. *VC* indicates the vestibulocochlear complex.

B, High-resolution CT scan shows the enlarged right vestibulocochlear complex with contrast material layered in the dependent position (*arrow*).

A 40-year-old man had intermittent leakage of clear fluid through both nostrils and profound right-sided hearing loss since childhood. During childhood, he had undergone a right-sided mastoidectomy for chronic purulent discharge of the right ear. He also had had unsuccessful surgery for a presumed defect in the floor of the anterior cranial fossa 2 years before the present admission. CT cisternography was performed, in which the temporal bone was studied in the absence of any demonstrable leak through the anterior cranial fossa and the roof of the sphenoidal sinus. A definite dehiscence was seen at the right lamina cribrosa, and leaked contrast material was visible within an enlarged vestibulocochlear complex (Fig 2A and B). The lateral semicircular canal was also enlarged. Contrast material was also identified within the right middle ear cavity and in the hypopharynx on the right side. At surgery, a 2 \times 1-mm bone chip was seen in the right middle ear cavity, embedded within the right oval window, where the CSF was leaking out.

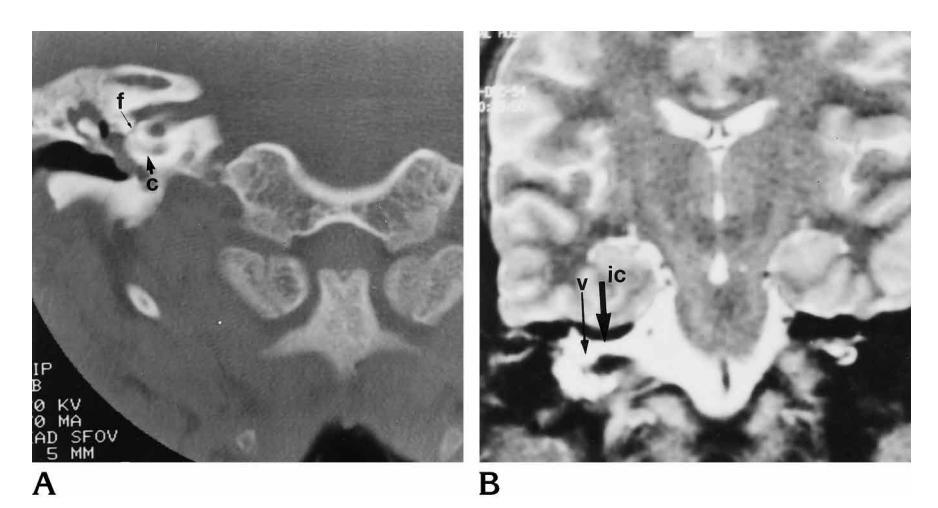
Fig 3. *A*, Plain coronal high-resolution CT scan through the internal auditory canals shows a linear fracture (f) through the right lamina cribrosa extending into the roof of the cochlear promontory (c), with CSF opacifying the middle ear cavity.

B, Fast spin-echo T2-weighted coronal MR cisternographic study shows a continuous hyperintense CSF column from the basal cistern through the right internal auditory canal (ic) into the vestibule (v), as well as a portion of the right mastoid air cells.

A 10-year-old boy had had bilateral CSF rhinorrhea, more pronounced on the right, and complete right-sided hearing loss for about 3 months after a fall. A CT cisternographic study performed elsewhere did not reveal a CSF fistula on the floor of the anterior cranial fossa, on the roof of the sphenoidal sinus, or on the tegmen tympani. On nasal endoscopic examination, CSF was seen to egress from the right eustachian tube. Hence, a plain high-resolution coronal CT study of the temporal bones was performed on the basis of our experience with the previous two cases. Fig 3A shows a definite linear fracture through the right lamina cribrosa and the roof of the cochlear promontory. MR cisternography based on the coronal T2weighted fast spin-echo sequence clearly shows a hyperintense column communicating between the basal CSF cistern and the middle ear cavity (Fig 3B). The right-sided mastoid air cells were also filled with fluid.
