**Unintended Consequences: Review of New  
Artifacts Introduced by Iterative  
Reconstruction CT Metal Artifact Reduction  
in Spine Imaging**

*AJNR Am J Neuroradiol* 2019, 40 (11) 1973-1975

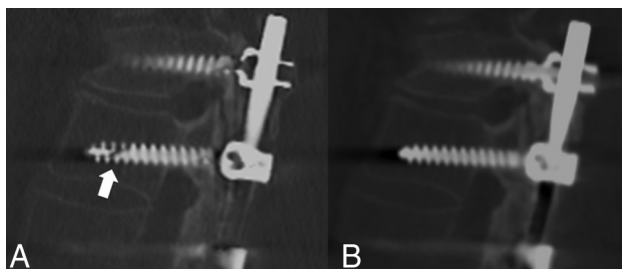
**FIG 3.** A, Sagittal CT image of posterior spinal fusion of the MAR protocol demonstrating lucency through the pedicle screw (white arrow). This lucency clearly mimics a fracture, hence could be called a “pseudofracture” if non-MAR images are not available. B, Image without the MAR application shows a normal appearance of the pedicle screw.

**Pedicle Screw Lucency.** Pedicle screw lucency occurs when the implanted hardware fatigues and fractures (Fig 3*A*, *white arrow*), which is not seen on the non-MAR image (Fig 3*B*). This artifact is not uniform throughout the MAR series, and adjacent images demonstrate that adjacent screws are unaffected.

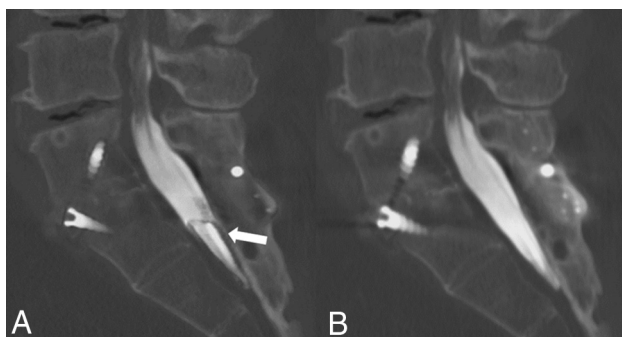
**FIG 4.** A, Sagittal MAR CT image with fusion hardware in the lumbar and sacral spine demonstrates apparent hypodense material (white arrow) in the dorsal spinal canal not seen in the non-MAR image. This filling defect could be mistaken for arachnoiditis, tumor, or layering debris and lead to unnecessary further work-up. B, Non-MAR image without evidence of material within the spinal canal.

**Subarachnoid Material on Myelography.** Factitious subarachnoid material can be seen on myelograms when MAR is applied, particularly in areas of concentrated intrathecal contrast. There is hypodense material in the dorsal spinal canal (Fig 4*A*, *white arrow*), which is not seen on the non-MAR image (Fig 4*B*). This artifact could be mistaken for arachnoiditis, tumor, or layering debris and may lead to unnecessary further work-up.

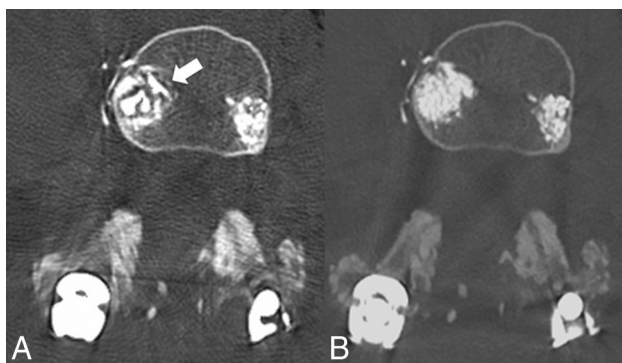
**FIG 5.** A, Axial CT image with MAR applied demonstrating an irregular fragmented appearance of bone cement with indistinct margins (white arrow). B, Non-MAR counterpart image with normal appearance of bone cement with accurate representation of vertebral filling.

**Intraosseous Cement Abnormal Distribution.** Postvertebroplasty cement configuration can appear irregular and fragmented with indistinct margins (Fig 5*A*, *white arrow*) and an internal heterogeneous pattern of vertebral body filling; however, in the non-MAR image (Fig 5*B*), the bone cement has a normal uniform distribution with clearly defined margins.
