## Can a Stent Retriever Damage the JET 7 Reperfusion Catheter?

J. Pearly Ti, L. Yeo and G. Anil

*AJNR Am J Neuroradiol* 2020, 41 (12) 2317-2319

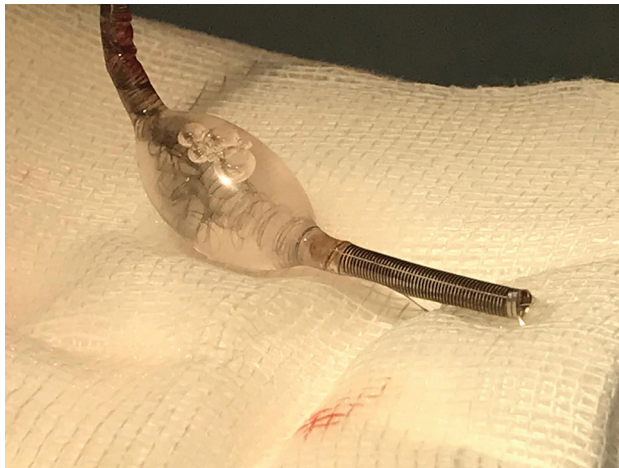
At this stage, while preparing the aspiration catheter, we noted that its distal end, approximately 15 mm proximal to its tip, was frayed. On connecting the catheter to the pressurized saline flush, the tip of the JET 7 started to balloon (Fig 1). This damaged JET 7 was replaced with an ACE68 aspiration catheter (Penumbra), and by means of the same technique, the procedure was completed to achieve TICI 3 reperfusion (On-line Fig 4). The total

**FIG 1.** The JET 7 catheter used in the thrombectomy for patient 1 shows ballooning of its distal end with separation of the reinforcing braids from the surrounding polymer.

The exact mechanism of the damage to the catheter in these cases is not clearly understood. Pulling an unsheathed stent through the aspiration catheter could potentially harm its integrity due to the friction between the two. However, in the first case, even this mechanism is not plausible because the stent retriever was pushed out of the distal end of the catheter after removing both the catheter and stent together as a single assembly, ie, without pulling it through the JET 7. We did not encounter similar incidents with use

of the earlier generations of Penumbra aspiration catheters. However, in the last 5 years, there is an ongoing race to manufacture wider bore aspiration catheters with better flexibility and trackability, without increasing their outer diameters. Intuitively, this pursuit could entail a certain degree of compromise on their strength. Operators need to be cognizant of such trade-offs between the stoutness of a catheter against its flexibility and softness, while choosing them off the shelf. In the 2 cases reported here, the distal end of the catheter, beyond the site of ballooning, could have fragmented and embolized or been retained within the patient. Following this experience, after each pass, we closely examine these aspiration catheters for their integrity before re-introducing them into the cerebral circulation.

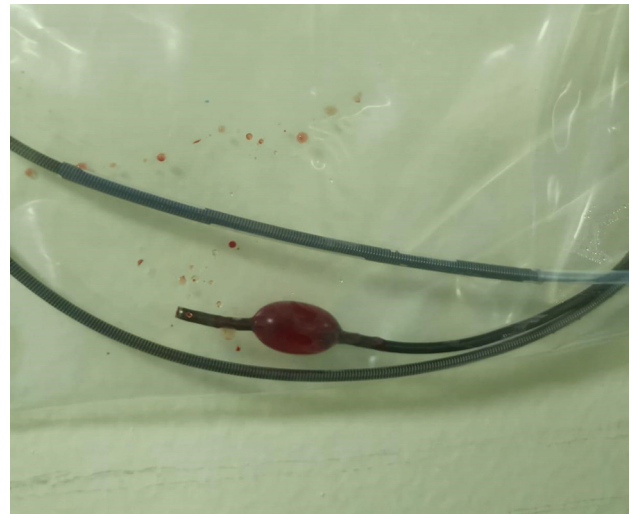
An 88-year-old woman presented with right M1 MCA occlusion and an NIHSS score of 12. Because she was outside the time window for intravenous thrombolysis, she was directly transferred to the angiosuite for mechanical thrombectomy. With the intention of using the direct aspiration first-pass technique, a JET 7 catheter was advanced over a 3MAX (Penumbra) and Transend 0.014-inch microcatheter-wire assembly, through a 6F Neuron MAX. However, it could not be navigated past the ledge of the ophthalmic artery origin. Hence, the procedure was converted to stent retriever thrombectomy. A 6 × 30 mm Solitaire-2 stent retriever (Medtronic) was deployed across the occlusion and allowed to integrate with the clot for 4 minutes. The Solitaire and the microcatheter were retrieved through the JET 7 with continuous suction using the ENGINE aspiration system. While we withdrew the stent retriever, the JET 7 spontaneously advanced beyond the ophthalmic segment of the ICA and wedged at the right M1-clot interface. Therefore, the operator decided to completely retrieve the Solitaire-microcatheter combination and left the JET 7 catheter in situ. The aspiration was continued for a further 3 minutes during which the aspiration tubing demonstrated slow continuous movement of blood toward the canister before removal of the JET 7. A subsequent angiogram showed TICI 3 reperfusion. When the JET 7 was flushed to check for clots *ex vivo*, we noted a similar ballooning (Fig 2) of the distal aspect of the catheter as described in case 1.

**FIG 2.** The damaged distal segment of the JET 7 thrombectomy catheter used in patient 2 has ballooned on flushing.
