**Unintended Consequences: Review of New  
Artifacts Introduced by Iterative  
Reconstruction CT Metal Artifact Reduction  
in Spine Imaging**

*AJNR Am J Neuroradiol* published online 3 October 2019  
<http://www.ajnr.org/content/early/2019/10/03/ajnr.A6238>

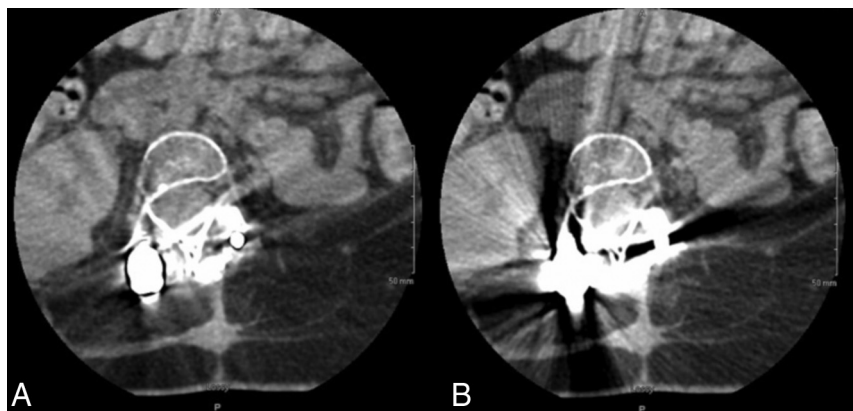
**FIG 1.** Axial lumbar CT images of a 15-year-old boy with spinal muscular atrophy type II who underwent posterior spinal fusion of T2–L5 due to severe scoliosis. *A*, MAR images demonstrating improved visualizations of soft tissues surrounding the hardware. *B*, Uncorrected images show artifacts covering soft tissues surrounding the hardware.

MAR reconstruction has been shown to significantly improve visualization of obscured soft-tissue structures and diagnostic confidence compared with the standard weighted filtered back-projection reconstruction method.<sup>12</sup> Paraspinal soft tissues adjacent to the fusion hardware are obscured on traditional images, while the MAR image allows adequate visualization of the underlying structures (Fig 1). Despite the clear benefits of applying MAR to decrease metal artifacts, MAR introduces its own unique artifacts.

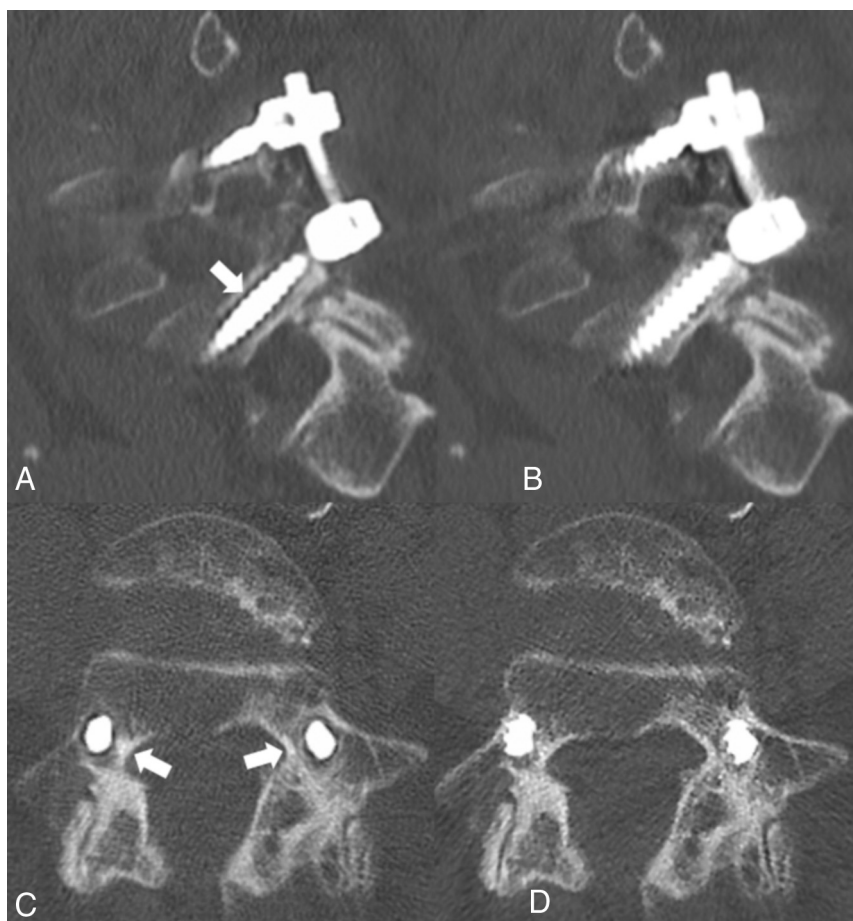
**FIG 2.** *A*, Sagittal CT image of posterior lumbar spinal fusion with the MAR technique applied shows lucency surrounding the L5 pedicle screw as indicated by the *white arrow*. *B*, Image *A* without the MAR protocol applied. *C*, Axial CT image shows bilateral pedicle screws with the MAR technique applied, demonstrating lucency surrounding the bilateral pedicle screws (*white arrows*). If the MAR images were viewed alone, these lucencies could be mistaken for hardware loosening. *D*, Image *C* without the MAR protocol applied.

**Perihardware Lucency.** Perihardware lucency (Fig 2A, white arrow) is concerning because it usually signifies loosening of the hardware; however, this is not visualized in the non-MAR images

(Fig 2*B*). More troublesome is that these artifacts persist in multiple planes as shown in the axial plane (Fig 2*C*, *-D*).

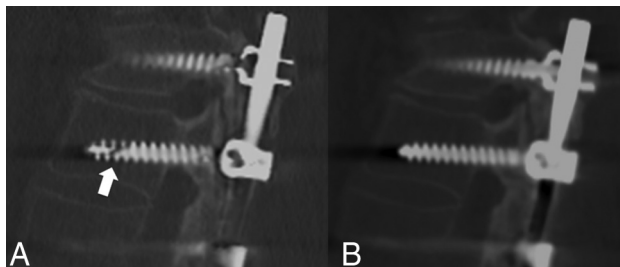
**FIG 3.** A, Sagittal CT image of posterior spinal fusion of the MAR protocol demonstrating lucency through the pedicle screw (white arrow). This lucency clearly mimics a fracture, hence could be called a “pseudofracture” if non-MAR images are not available. B, Image without the MAR application shows a normal appearance of the pedicle screw.

**Pedicle Screw Lucency.** Pedicle screw lucency occurs when the implanted hardware fatigues and fractures (Fig 3*A*, *white arrow*), which is not seen on the non-MAR image (Fig 3*B*). This artifact is not uniform throughout the MAR series, and adjacent images demonstrate that adjacent screws are unaffected.

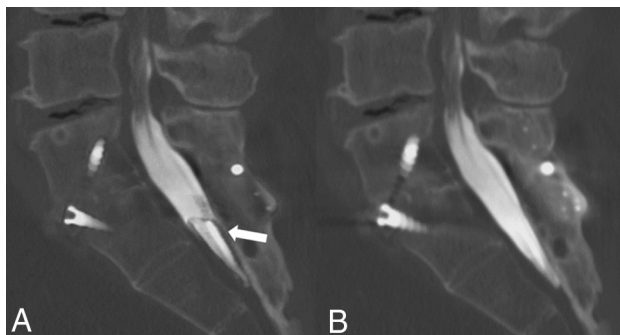
**FIG 4.** A, Sagittal MAR CT image with fusion hardware in the lumbar and sacral spine demonstrates apparent hypodense material (white arrow) in the dorsal spinal canal not seen in the non-MAR image. This filling defect could be mistaken for arachnoiditis, tumor, or layering debris and lead to unnecessary further work-up. B, Non-MAR image without evidence of material within the spinal canal.

**Subarachnoid Material on Myelography.** Factitious subarachnoid material can be seen on myelograms when MAR is applied, particularly in areas of concentrated intrathecal contrast. There is hypodense material in the dorsal spinal canal (Fig 4*A*, *white arrow*), which is not seen on the non-MAR image (Fig 4*B*). This artifact could be mistaken for arachnoiditis, tumor, or layering debris and may lead to unnecessary further work-up.

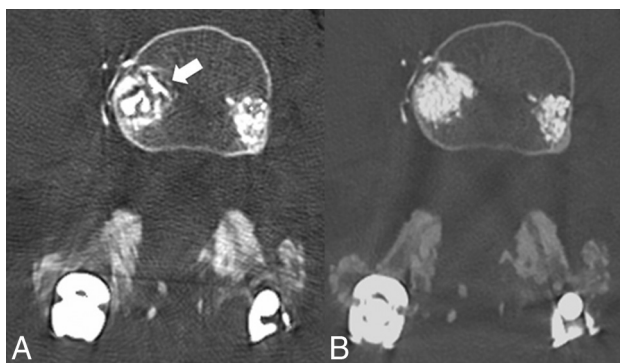
**FIG 5.** A, Axial CT image with MAR applied demonstrating an irregular fragmented appearance of bone cement with indistinct margins (white arrow). B, Non-MAR counterpart image with normal appearance of bone cement with accurate representation of vertebral filling.

**Intraosseous Cement Abnormal Distribution.** Postvertebroplasty cement configuration can appear irregular and fragmented with indistinct margins (Fig 5*A*, *white arrow*) and an internal heterogeneous pattern of vertebral body filling; however, in the non-MAR image (Fig 5*B*), the bone cement has a normal uniform distribution with clearly defined margins.
